**Illogan Sports Ground (Changing Rooms)**

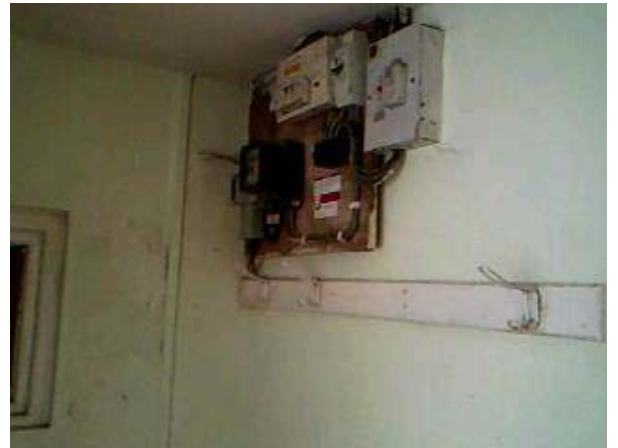
<b>UPRN:</b>	-	<b>Block No.</b>	1	<b>Floor No.</b>	0	<b>Room No.</b>	-
<b>Room Description:</b>	Kitchen

Sample Ref. No:	1/0/-/P	
Material Location:	Presumed flashguards within electrical box on wall	
Approx. Quantity (m <sup>2</sup> ):	Unknown	
Accessibility:	Low	
<b>Material Assessment Score</b>		<b>Score</b>
Product Type:	Presumed asbestos textile	2
Condition:	Presumed good	0
Treatment:	Enclosed	1
Asbestos Type:	Presumed chrysotile	1
Total:		4
Comments:
